Subject: oil in the air box

Model: Nevada 750

TECHNICAL COMMUNICATION No. 02-2003**17 April 2003**

Subject: engine oil level**Model: Breva V750 i.e.****Frames involved: all**

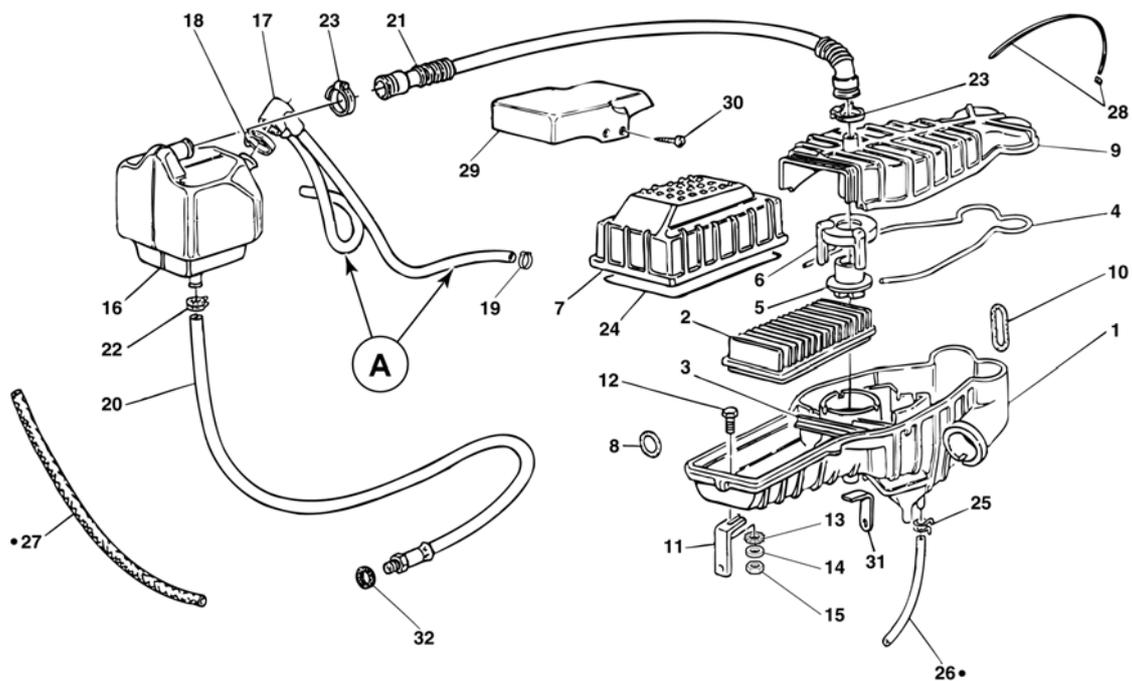
The presence of oil in the decanter box and -following oil vapours circuit- in the air box has two main causes:

- too high oil level
- high pressure of the gases inside the crankcase

- Check that the two hoses (A) taking the oil vapours from the head covers to the decanter are not squashed due to their flexibility; if so, change them with more rigid hoses.

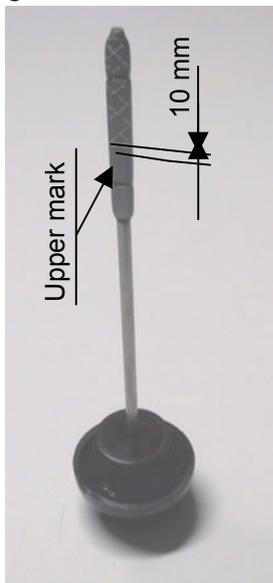
An excessive quantity of engine oil can cause an increase in the oil extracted by the crankcase gas recover circuit. In exceptional cases an oil present in the transparent recovery tube, which extends from the filter housing to the rear joint of the right half cradle, type of anomaly can be experienced.

Check the correct engine oil level to avoid this inconvenience.

The checking operation can be easily carried out by using the oil filler cap dipstick. The correct quantity of oil wets the dipstick up to around 10-11 mm under the maximum level reference mark. The highlighted part in the photo shows the section of dipstick which must be wet. The check must be carried out with the engine warmed up, after around 20 minutes that it is running.

It may be useful to make a reference mark at the indicated quota, to facilitate the check during regular engine oil replacements.
